Experimental and analytical investigation of dynamic crack patterns in automotive windshield sheets subjected to low velocity impact

In this study, some drop ball tests in different impact energy levels are conducted in order to monitor fracture behavior of an off-road automotive windshield. Also dynamic crack patterns of laminated glasses are examined based on the impact energy levels and impact conditions. In addition, the acceleration which is imposed to impactor during the accident is recorded. The experimental results are compared to an analytical approach regarding the resultant impact force as well. There is a good agreement between the impact forces of experimental test results and analytical approaches ones. All in all, in low velocity impacts, impact energy releases through powdering region in impact area, radial cracks and strain energy in PVB. It is concluded that in lower impact energy levels, the higher impact speed, the more number of radial cracks. In addition, at higher energy levels, number of radial cracks decrease due to higher strain energy levels in PVB interlayer. Therefore, in low velocity impacts, number of radial cracks has reverse relationship with penet

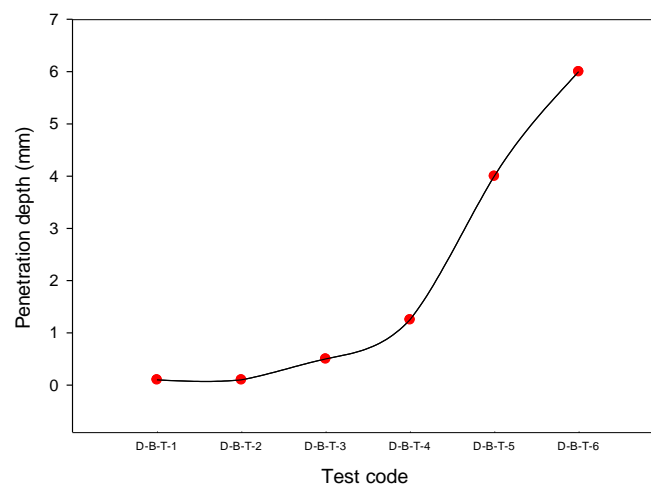
Fig17. Penetration depth in conducted drop ball tests

In addition, Number of radial cracks versus test code No is shown in Fig. 16. Also penetration depth graph at the center of specimens in different drop ball tests is shown in Fig.17

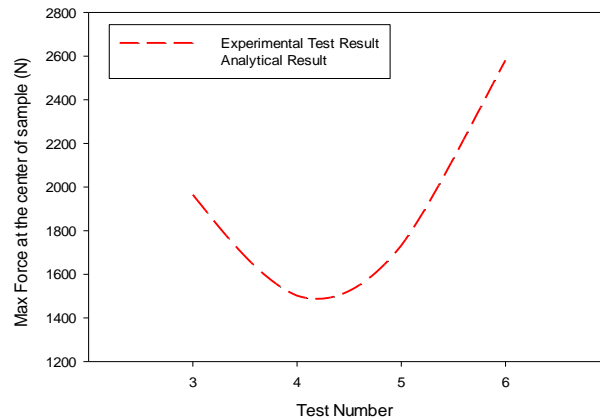
Fig.18. Comparison between experimental test and analytical approach in terms of maximum force at the center of specimen

The acceleration and corresponding maximum force of impactor have been calculated by the theoretical formulas and compared with experimental tests. As it is shown in Fig.18 there is a good agreement between the experimental test results and theoretical approach in terms of maximum force which is imposed to impactor.
